Regeneration with Dwelling Unit Enlargement of Public Housing in Japan

Kozo KADOWAKI, Seichi FUKAO and Tsuyoshi ARAHIRA
*Department of Architecture and Building Science
Tokyo Metropolitan University, Japan*

Abstract: In Japan, there is growing demand for renovation of the deteriorating housing estates built in the mass-housing era. Although the houses were originally designed for nuclear families, they are now considered too small to accommodate more than three residents. Dwelling units are often enlarged by removing partition walls or by constructing extensions. This paper outlines trials of housing renovation with dwelling unit enlargement in Japan.

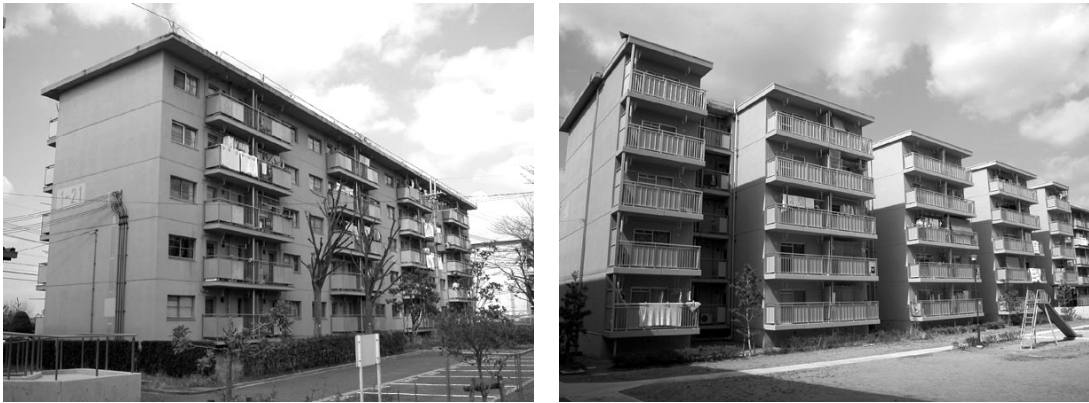
Figure 1 Building Before and After Extension

Extension to the balcony side of buildings is the most frequent dwelling enlargement method in Japan (see Figures 1 and 2). The extension and the existing building connect via an opening where a glazed door was formerly situated. There is no need to make a new opening in the existing concrete wall, and existing interior finishings or functional systems are not generally repaired. However, this method is not suitable for buildings that are deteriorating. The extension is built of precast concrete panels or the like to enable quicker construction.

A bath unit or washroom is often located in the extension to supplement lacking function. A washroom and a washing machine space are located in the example shown in Figure 1 and 2.

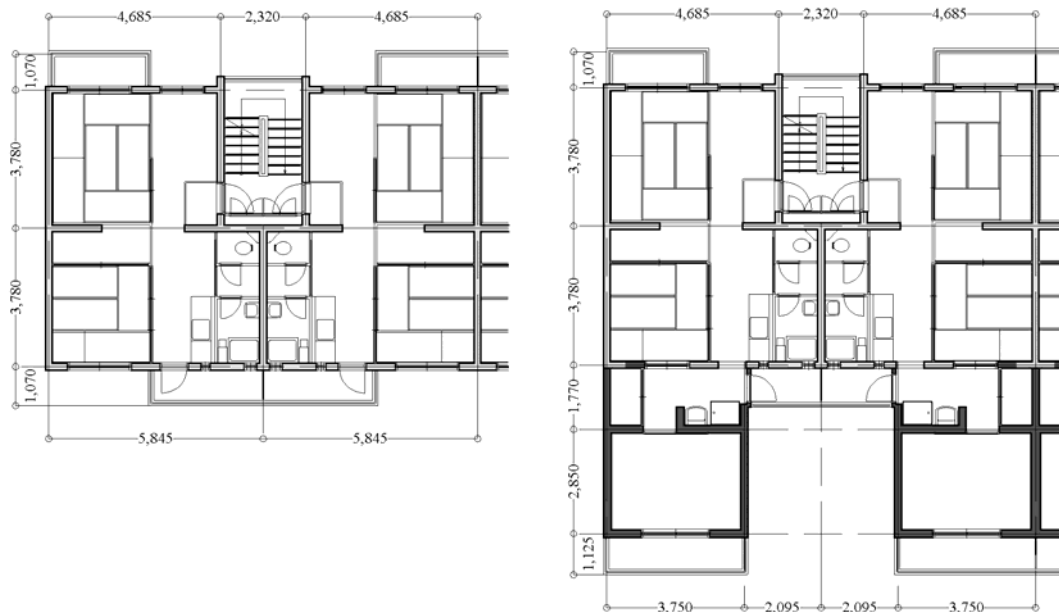
Figure 2 One Pair of Dwelling Units Plans Before and After Extension

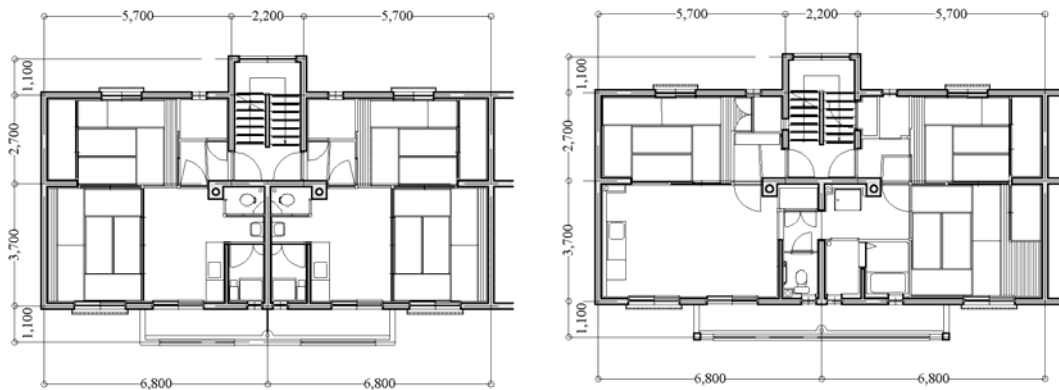
Figure 3 Dwelling Unit Plans Before and After Connection of Two Units

Dwelling units are sometimes rearranged. The most familiar method of rearranging a dwelling unit is the connection of two units by making an opening in the partition wall as shown in Figure 3. Rearrangement of three units into two or four units into three by removing sections of partition walls and installing new partition walls is common. Such renovation often follows

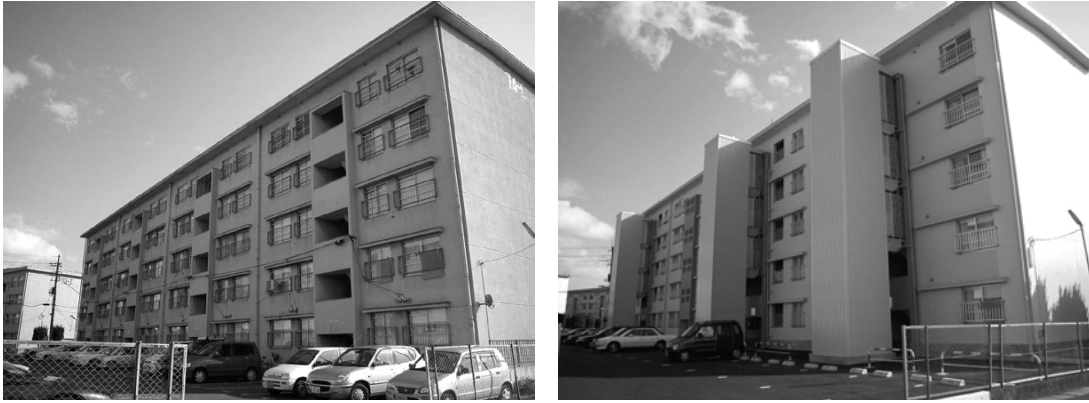
Figure 5 Building Before and After Elevator Towers Addition

One solution is the addition of an elevator tower to the stairwell of the building (see Figure 5). This method requires no repair to the existing building. However, it is necessary to add several elevators to one building, so that both initial and running costs accumulate. Moreover, this method does not achieve barrier free access to the dwelling as Figure 6 illustrates.

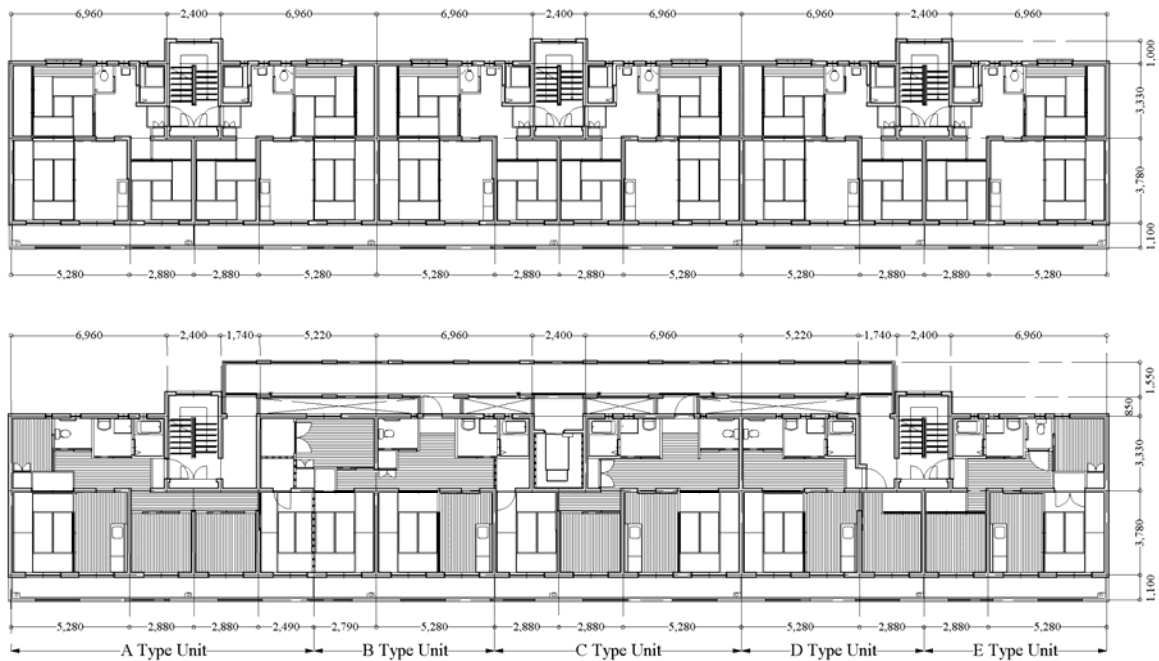
Figure 7 Floor Plans Before and After Access Corridors and an Elevator Addition

The alternative is to add access corridors and an elevator tower to the building (see Figure 7). This requires drastic change to the existing building skeleton and interior layout. Rearrangement of dwelling units is performed at the simultaneously in most cases.
