Kozo KADOWAKI, Seiichi FUKAO and Tsuyoshi ARAHIRA Department of Architecture and Building Science Tokyo Metropolitan University, Japan

Abstract: In Japan, there is growing demand for renovation of the deteriorating housing estates built in the mass-housing era. Although the houses were originally designed for nuclear families, they are now considered too small to accommodate more than three residents. Dwelling units are often enlarged by removing partition walls or by constructing extensions. This paper outlines trials of housing renovation with dwelling unit enlargement in Japan.

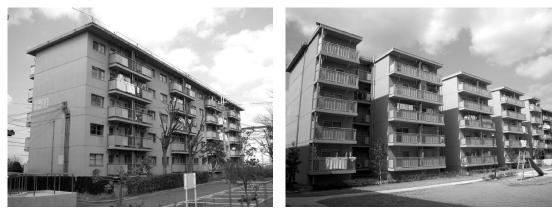
Extension to the balcony side of buildings is the most frequent dwelling enlargement method in Japan (see Figures 1 and 2). The extension and the existing building connect via an opening where a glazed door was formerly situated. There is no need to make a new opening in the existing concrete wall, and existing interior finishings or functional systems are not generally repaired. However, this method is not suitable for buildings that are deteriorating. The extension is built of precast concrete panels or the like to enable quicker construction.

Figure 1 Building Before and After Extension

A bath unit or washroom is often located in the extension to supplement lacking function. A washroom and a washing machine space are located in the example shown in Figure 1 and 2.

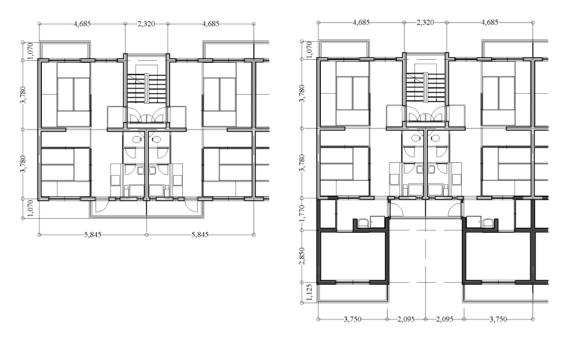
Figure 2 One Pair of Dwelling Units Plans Before and After Extension

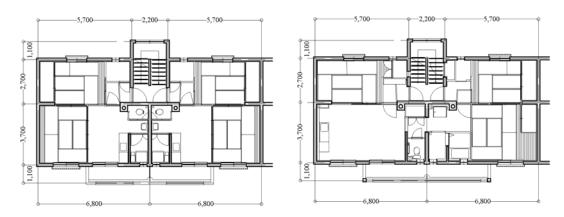
Dwelling units are sometimes rearranged. The most familiar method of rearranging a dwelling unit is the connection of two units by making an opening in the partition wall as shown in Figure 3. Rearrangement of three units into two or four units into three by removing sections of partition walls and installing new partition walls is common. Such renovation often follows

Figure 3 Dwelling Unit Plans Before and After Connection of Two Units

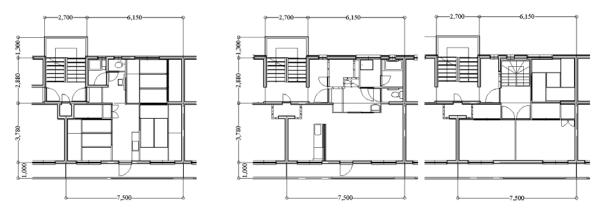
The flats on the upper and lower sides are occasionally changed into a duplex (see Figure 4). In this five-story building, the 5th floor unit and the 4th floor unit were changed into a duplex. This change was made because many units on the 5th floor had been empty before renovation due to the tiring climb up the stairs to reach the 5th floor.

Figure 4 Dwelling Units Plans Before and After Flats into Duplex, Original Dwelling Unit Plan, Lower Floor Plan and Upper Floor Plan of Duplex

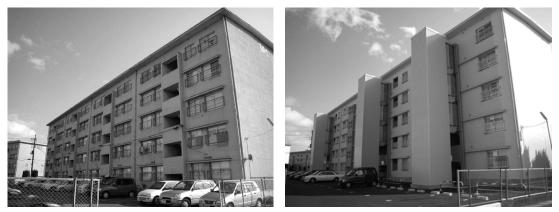
One solution is the addition of an elevator tower to the stairwell of the building (see Figure 5). This method requires no repair to the existing building. However, it is necessary to add several elevators to one building, so that both initial and running costs accumulate. Moreover, this method does not achieve barrier free access to the dwelling as Figure 6 illustrates.

Figure 5 Building Before and After Elevator Towers Addition

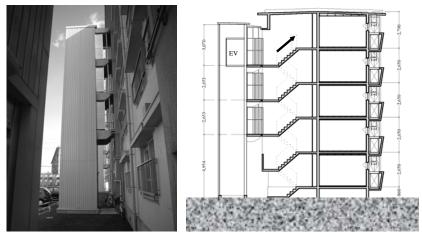
Figure 6 Building Section Showing Added Elevator Tower

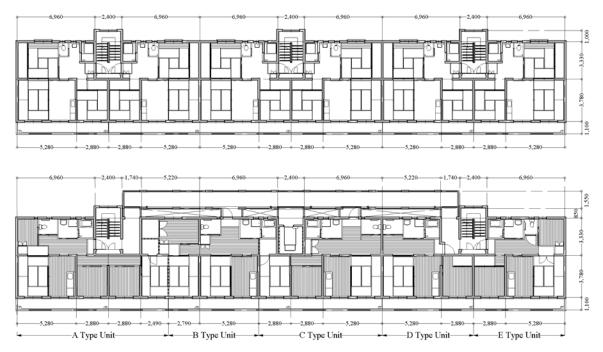
The alternative is to add access corridors and an elevator tower to the building (see Figure 7). This requires drastic change to the existing building skeleton and interior layout. Rearrangement of dwelling units is performed at the simultaneously in most cases.

Figure 7 Floor Plans Before and After Access Corridors and an Elevator Addition

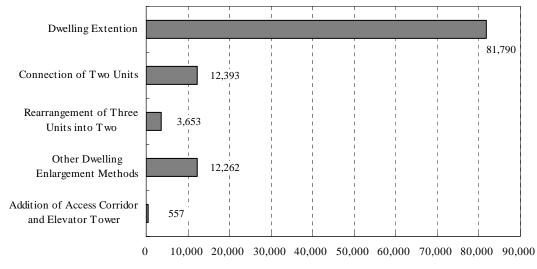
The survey focused on the following methods: dwelling extension, connection of two units, rearrangement of three units into two units, other dwelling enlargement methods, and the addition of access corridors and elevator towers. Figure 8 indicates each total of recreated dwelling units. This figure shows that dwelling extension is the most common method in Japan, and the next common is the connection of two units. The total number of access corridor added units does not include the number of simultaneous enlarged units. The number of access corridors added and enlarged units would be much greater much more. A total of 1,238,680 units are managed by these bodies, and the sum of recreated units accounts for 8.93% (110,655 / 1,238,680).

Figure 8 Total of Recreated Units in Japan

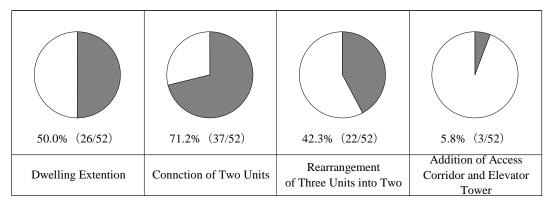
Figure 9 indicates how many bodies conducted each method. As many as 68% (two thirds) conducted connection of two units, 43% rearranged three units into two units, and 50% extended dwellings. Only 7% added new access corridors.

Figure 9 Rate of Bodies Who Have Conducted Housing Regeneration
