Development of a New Elevator Addition System for Aged Residential Buildings

Hitoshi Ogawa, Seiichi Fukao, Shinji Yamazaki,
Katsuhiro Kobayashi, Kozo Kadowaki, Susumu Minami
Tokyo Metropolitan University,
192-0397, 1-1 Minamiosawa, Hachioji, Tokyo, Japan
ogawa-hitoshi1@c.metro-u.ac.jp

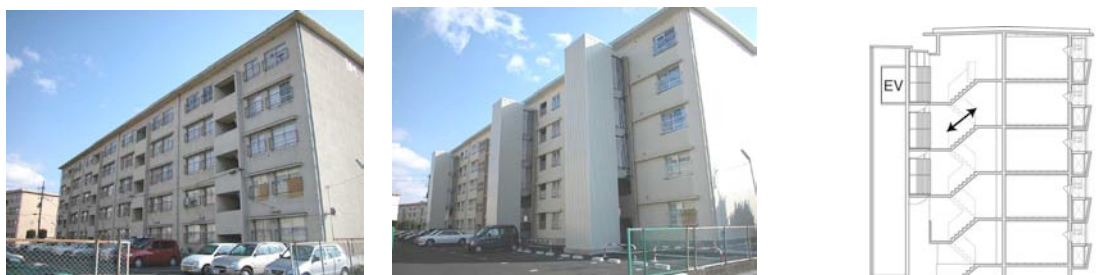
Figure 1. Building before and after the renovation work involving the addition of elevator towers, and section view

Firstly, we analyzed architects drawings of approximately 30 public residential buildings to which elevators have been added, and classified the buildings according to type. The most common type is that of buildings with the addition of an elevator tower to the outside of each of the staircases in the building. This method does not result in totally barrier free access to the dwellings because the elevator car has to stop at the landings of stairways, so that residents have to go up or down half the story height on foot.

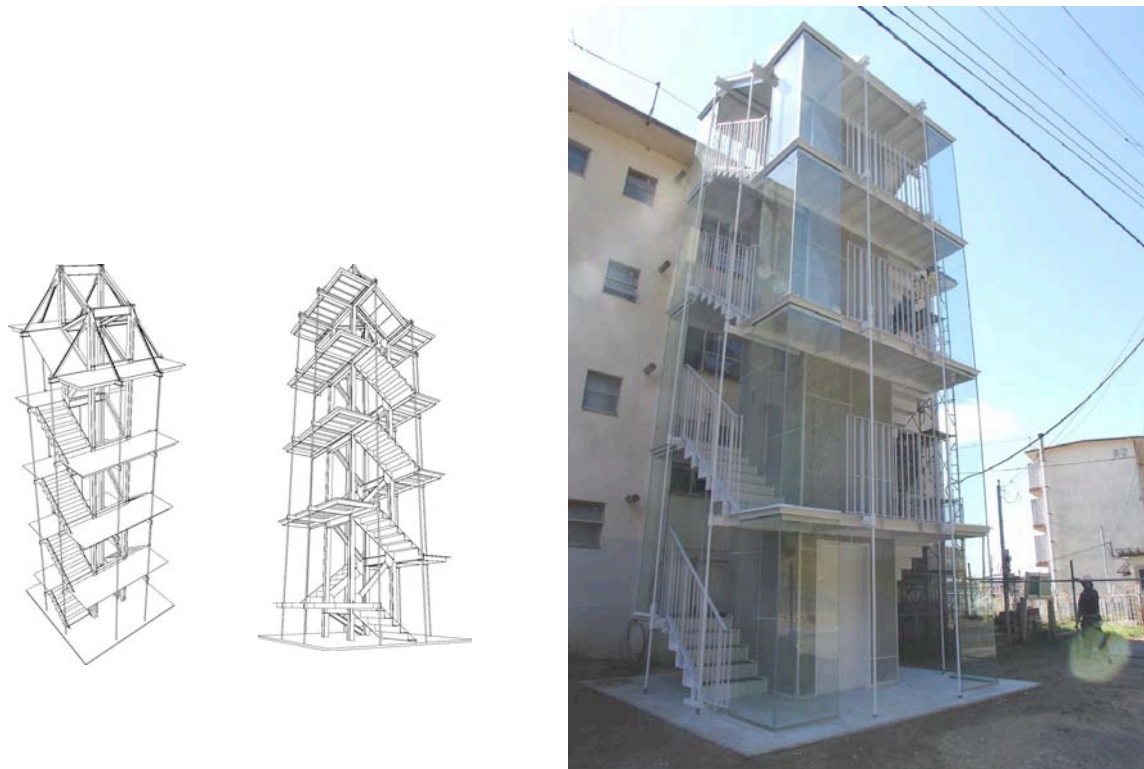
Figure 3. Structural diagrams of new system and photograph of the new elevator addition system applied

We designed this system to be compatible with a compact elevator. In Japan, elevators are generally high quality, but large and expensive. Although large elevators are structurally stable, it makes the existing staircase dark and unattractive. So, we propose a structural system that uses slender tension rods around a compact elevator shaft, which provides not only structural enforcement, but also gives a lighter impression of the elevator tower unit.

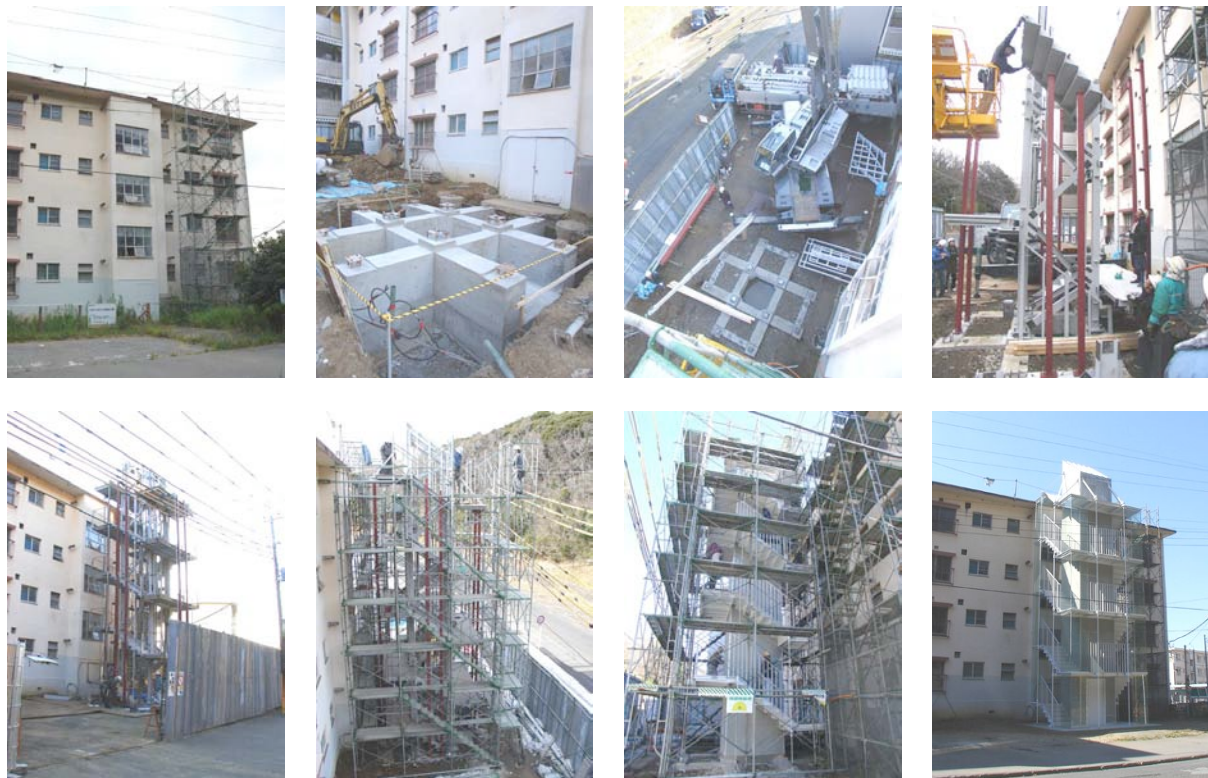
Figure 4. Process photographs of construction site

After finishing the design in detail, steel pieces were fabricated in a factory. At the same time, the ground was excavated and the foundations were laid. After finishing the prefabrication, the steel pieces were delivered to the site and the steel skeleton was erected. Then, the steel rods around the elevator shaft were tensed up. Hereafter, construction work was carried out in series; the exterior wall of the elevator shaft was set, the elevator shaft was covered with a roof, metal work was completed, the steelwork was painted, glass panels were set in the stair landings and the floors were finished.
